NAVAL AIR ENGINEERING CENTER LAKEHURST N J ENGINEERIN--ETC F/G 1/5
METALLURGICAL ANALYSIS OF ARRESTING GEAR DECK PENDANT FAILURES.(U)

NAEC-ENG 7910

METALLURGICAL ANALYSIS

ARRESTING GEAR DECK PENDANT FAILURES

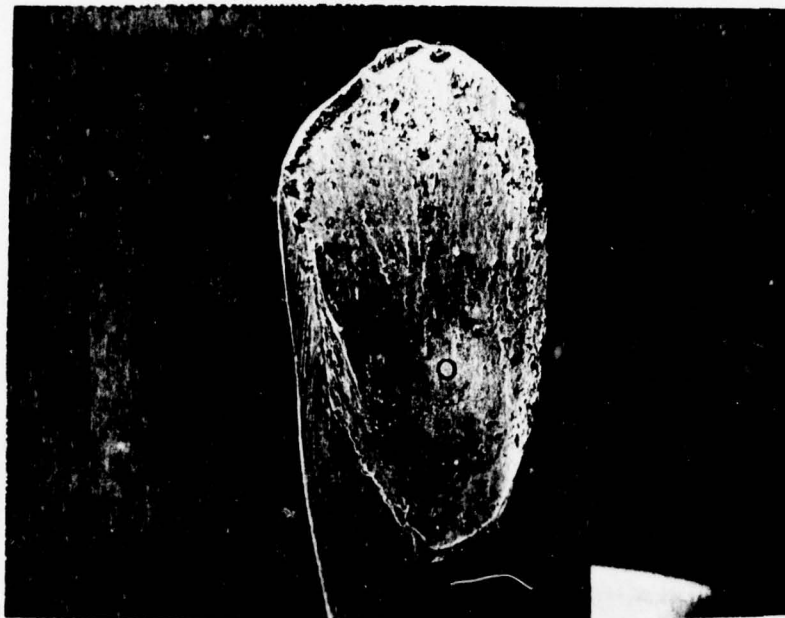
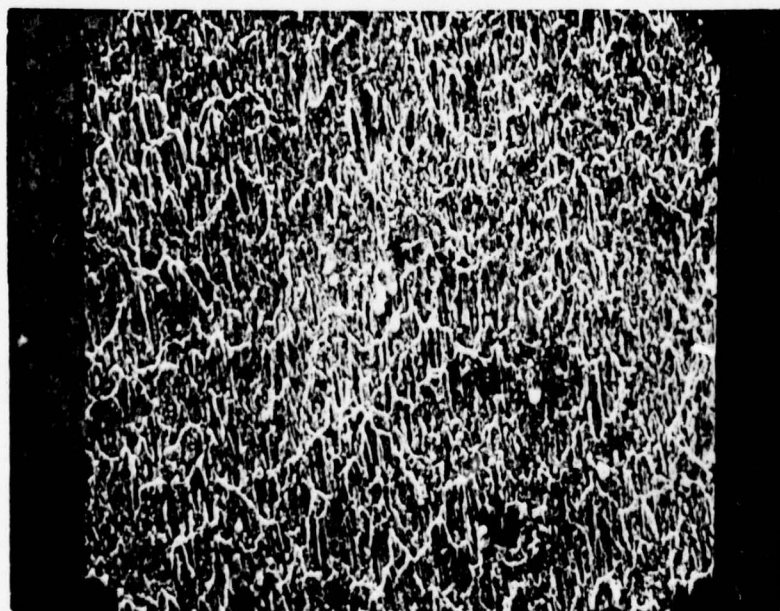
FIGURE 3

SEM photograph of 45° shear fracture. The area contained in "O" is shown below.

SEM photograph of transgranular fracture resulting from an overload failure.

Typical Shear Fracture

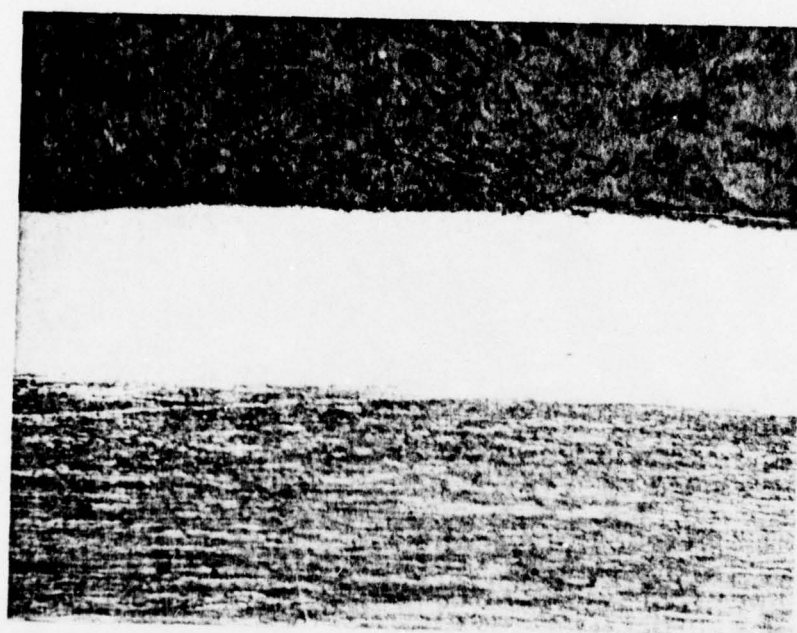
FIGURE 6

Typical layer of "white martensite"

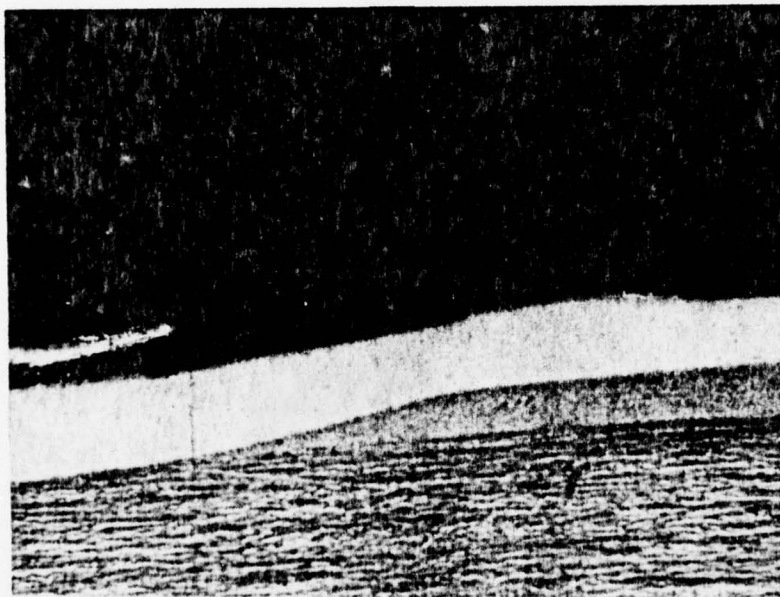
FIGURE 7

NOTE that maximum thickness has not been changed by second arrestment

Details of a multiple hit wire sample showing a freshly formed layer of "white martensite" on top of a tempered layer.

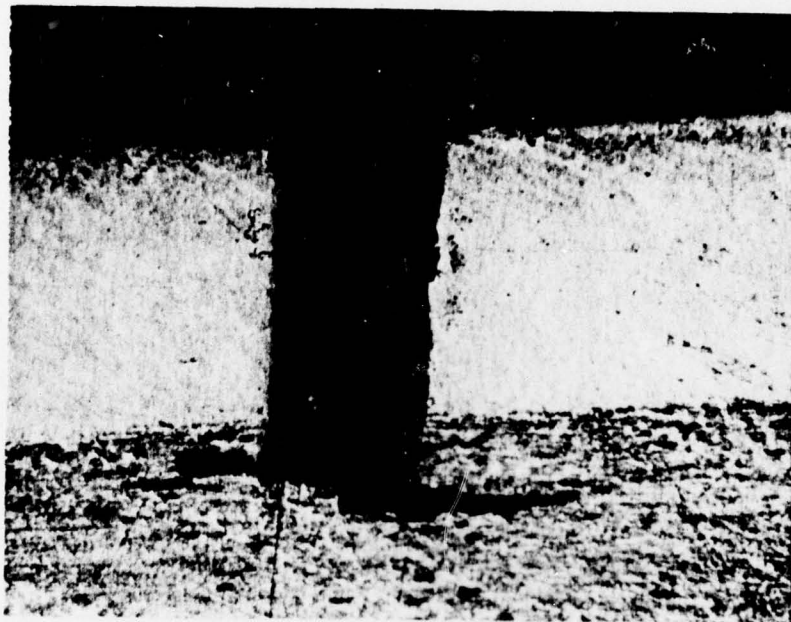
FIGURE 9

The preponderance of the irregular jagged fractures were found in three adjacent strands. It is believed that failure first occurred in these strands. In the opposite strands the wires exhibited mostly tensile and shear fractures. When martensitic-type surface layers were present in these strands, any perpendicular crack appeared to stop as it extended into the base metal. The cracks would tend to "blunt out" as they entered the base metal. (See figure 9).

NOTE how crack
propagation stops after
slightly penetrating
base metal

Details of a Blunted Crack

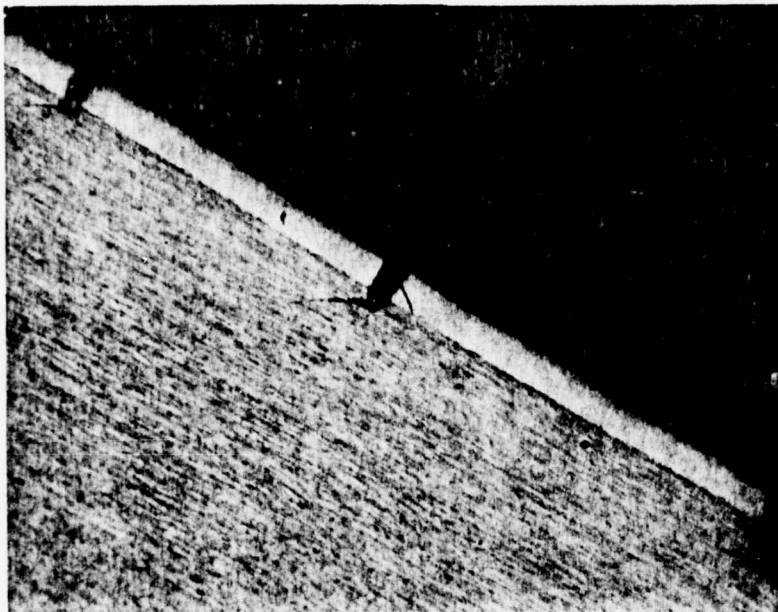
FIGURE 14

Wires opposite direct
hook slide.

Cracks formed in wires rubbed by hook point vs. cracks in wires opposite
hook slide.

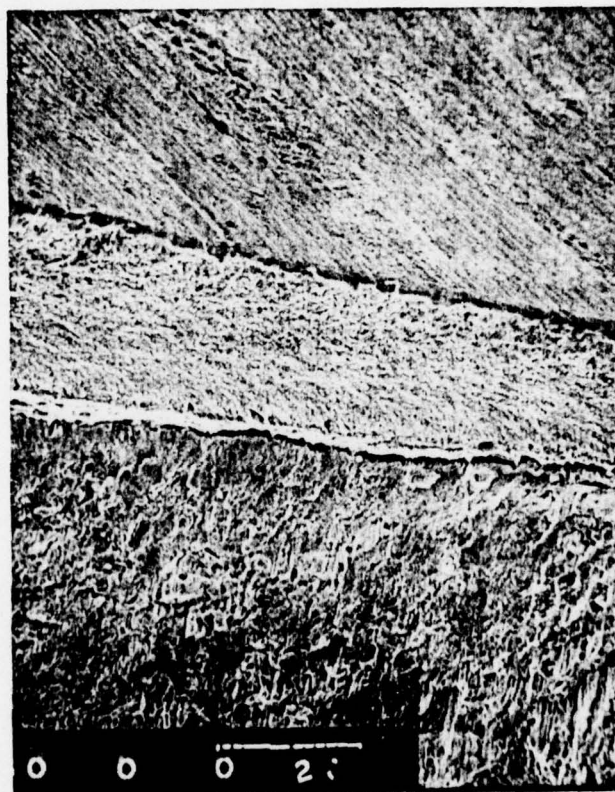
FIGURE 16

NOTE Martensite layer
at top and center, and
ductile shearing
below.

"White martensite" induced fracture.

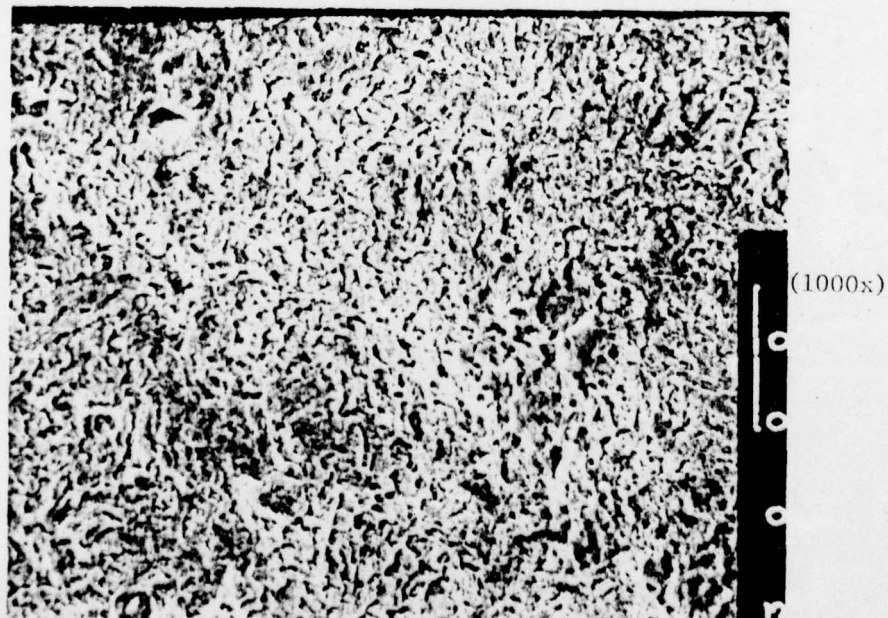
FIGURE 19

Individual wire fracture illustrating apparent fatigue structure.
